DOE/ID-10750

May 2000

***Institutional Controls Status Report at
Test Area North, Waste Area Group 1***

**Prepared for the
U.S. Department of Energy
Idaho Operations Office**

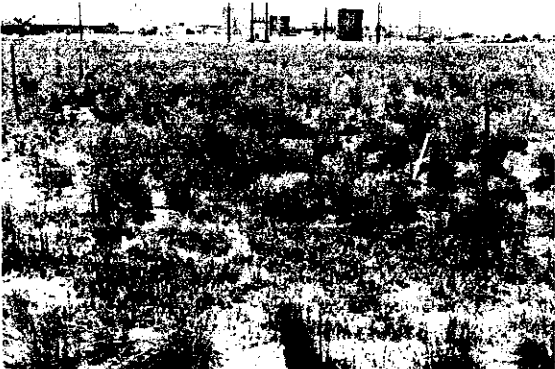
TSF-03 Burn Pit		Facility Security Fence	Signs	Fences	Other	Administrative for Access to the Site	Administrative to Work at the Site
<p>History: The TSF-03 Burn Pit is located northwest of Columbia Street gate access, outside the TSF facility fence. The Burn Pit was potentially used for open burning of combustible waste from 1953 to 1958. The site has been backfilled, subsidence control has been maintained, and vegetation has been reestablished. The pit received refuse, construction debris, and combustible liquids (i.e., petroleum products) from the TAN areas. It is possible that some oil, Stoddard solvent, and oily waste (from the limited maintenance activities at TAN) were burned at the pit.</p> <p>Contaminant of Concern: lead</p> <p>Action: Remedial action is to install native soil cover. A contingency remedy is excavation and disposal of contaminated soil.</p>		No	Environmental Control Sign	Yes, gate open	No	Access control, sign in	STD-101

<p>Comments</p> <p>This site was closed to all personnel during March 2000. Notes from inspection of November 3, 1999, were used.</p>					
Photo File: PN 99-0405-4-28		Inspection Date: November 3, 1999

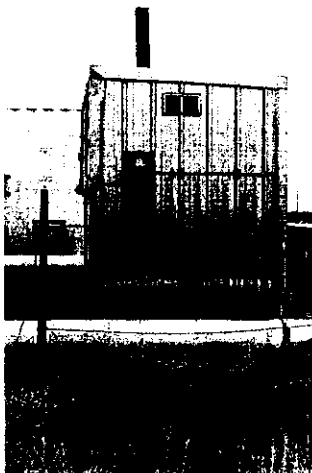
Photo File: PN000128-40

TSF-05 Injection Well

TSF-05 injection well was drilled in 1953 to a depth of 93.0 m (305 ft) to dispose of liquid effluent generated from the ANP Program slated to be sited at TAN. The well was last used as a primary disposal site in September 1972, after which wastewaters were diverted to the TSF disposal pond. Discharges included treated sanitary sewage, process wastewaters, and low-level radioactive waste streams from TSF-09 and TSF-26.

Contaminants of Concern: cis-1,2-dichloroethene, trans-1,2-dichloroethene, trichloroethene, tetrachloroethene, Sr-90, tritium, Cs-137, and U-234.

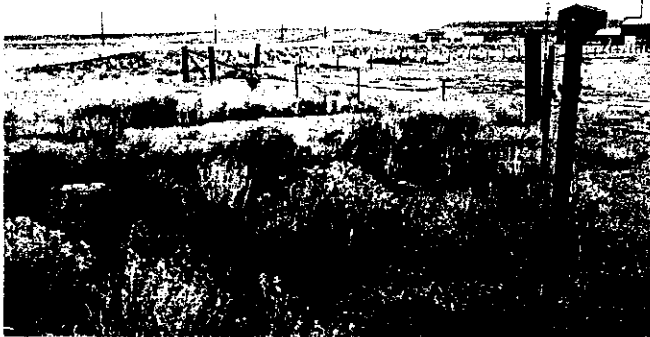
TSF-06, Area 5 Radioactive Soil Berm		Facility Security Fence	Signs	Fences	Other	Administrative for Access to the Site	Administrative to Work at the Site
<p>History: TSF-06 is a large, open, soil area with elevated levels of radioactive contamination, which also contains 13 subareas with discrete boundaries and types of contaminants. The main contaminants of concern are Cs-137, Co-60, and Sr-90. Source of contamination in Area B is windblown contamination from soil surrounding the PM-2A tanks (TSF-26).</p> <p>Contaminant of Potential Concern: radionuclides.</p> <p>Action: No Action Site requiring institutional control.</p>		Yes	Yes	Yes	Gated entry point by bully barn	Access restricted, RWP, POD	RWP, POD, STD-101

<p>Comments:</p> <p>Site within TSF-06 area fence.</p>					
<p>Photo File: PN000128-21</p>		<p>Inspection Date: March 23, 2000</p>

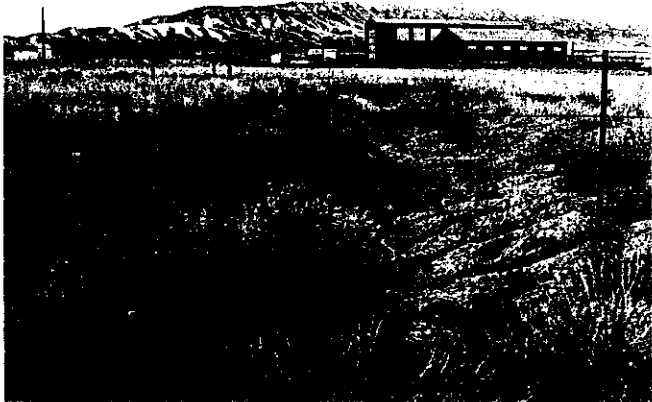
Photo File: PN000128-24		Inspection Date: March 23, 2000

TSF-06, Area 11 TSF-06 Ditch		Facility Security Fence	Signs	Fences	Other	Administrative for Access to the Site	Administrative to Work at the Site
History: TSF-06 is a large, open, soil area with elevated levels of radioactive contamination, which also contains 13 subareas with discrete boundaries and types of contaminants. The main contaminants of concern are Cs-137, Co-60, and Sr-90. Source of contamination in Area B is windblown contamination from soil surrounding the PM-2A Tanks (TSF-26). Contaminant of Potential Concern: radionuclides. Action: No Action Site requiring institutional control.		Yes	Yes	Yes	Gated entry point by bully barn	Access restricted, RWP, POD	RWP, POD, STD-101

Comments: Site is within TSF-06 area fence. The "Y" shaped ditch is of concern in two areas only; the west end of the ditch, and the northern leg of the "Y". Photo shows the northern end of the ditch. The remainder of the ditch is clean.
